3 Introduction

3.1 Project Background

The scope of this document is to provide an overview of past findings related to a Graphium implementation at a Cisco-based hospital, and outline the changes necessary to remediate them.

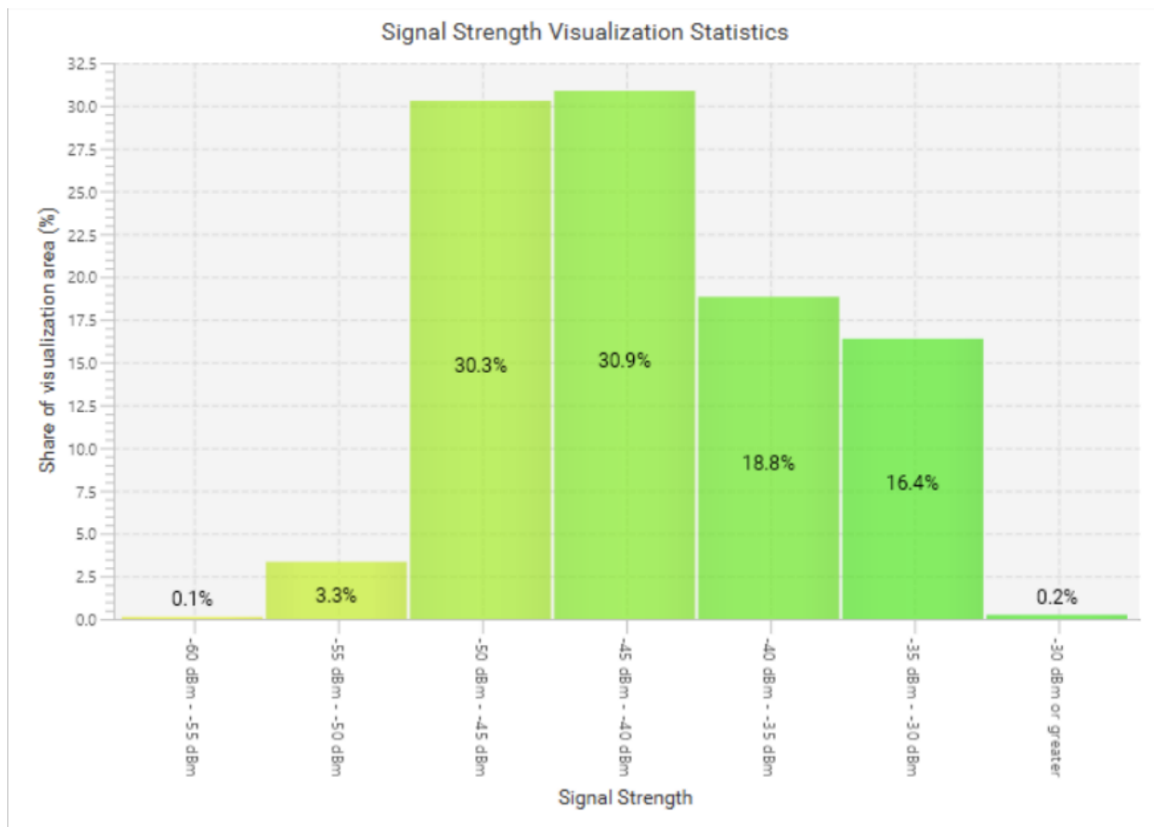
6.1 Heat Map

In this section, you will find a heat map of the environment. This visual heat map shows only the strength of the RF signal for the indicated area. As a reference, there are three different categories in which to group the signal strength. These are:

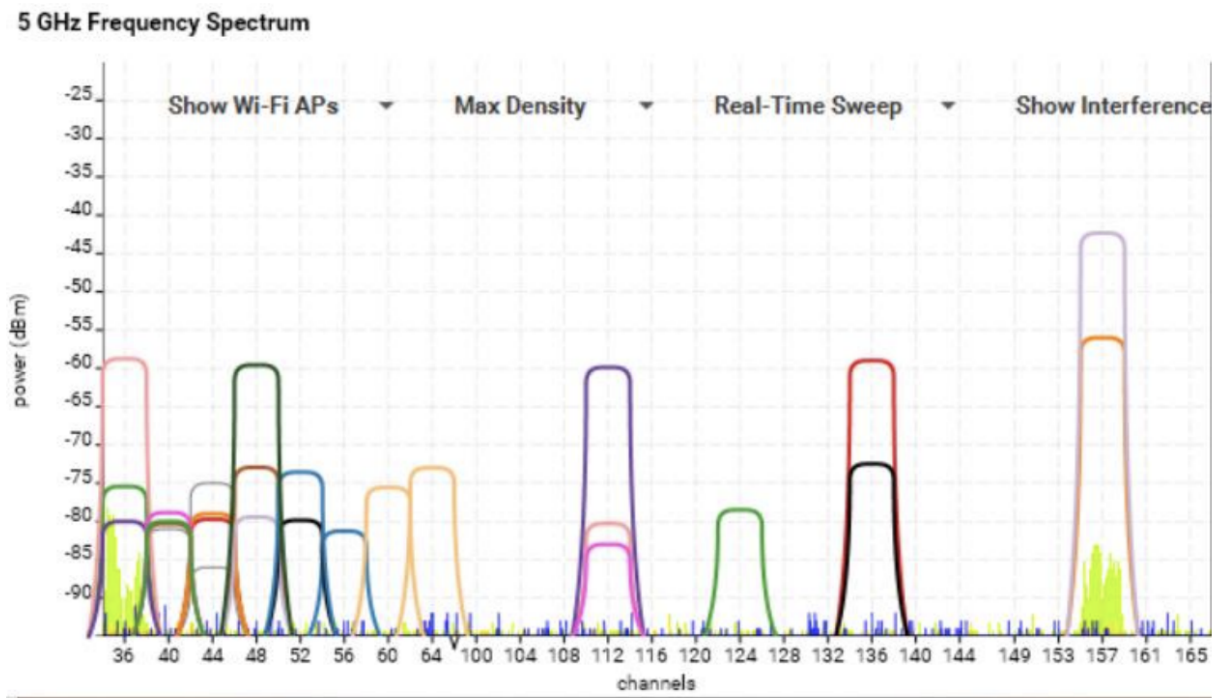
However, in the next image you can see multiple sources of coverage on the same channels and these can cause the CCI we detected.

Referring to the same image, we see congestion in the UNII-1 band, and not much use elsewhere. Utilizing all available channels will improve the health of the WiFi environment, and that really cannot be overstated. There are some older devices that are still not compatible with UNII-2 Extended channels, so be mindful of that if you have any devices having trouble connecting.

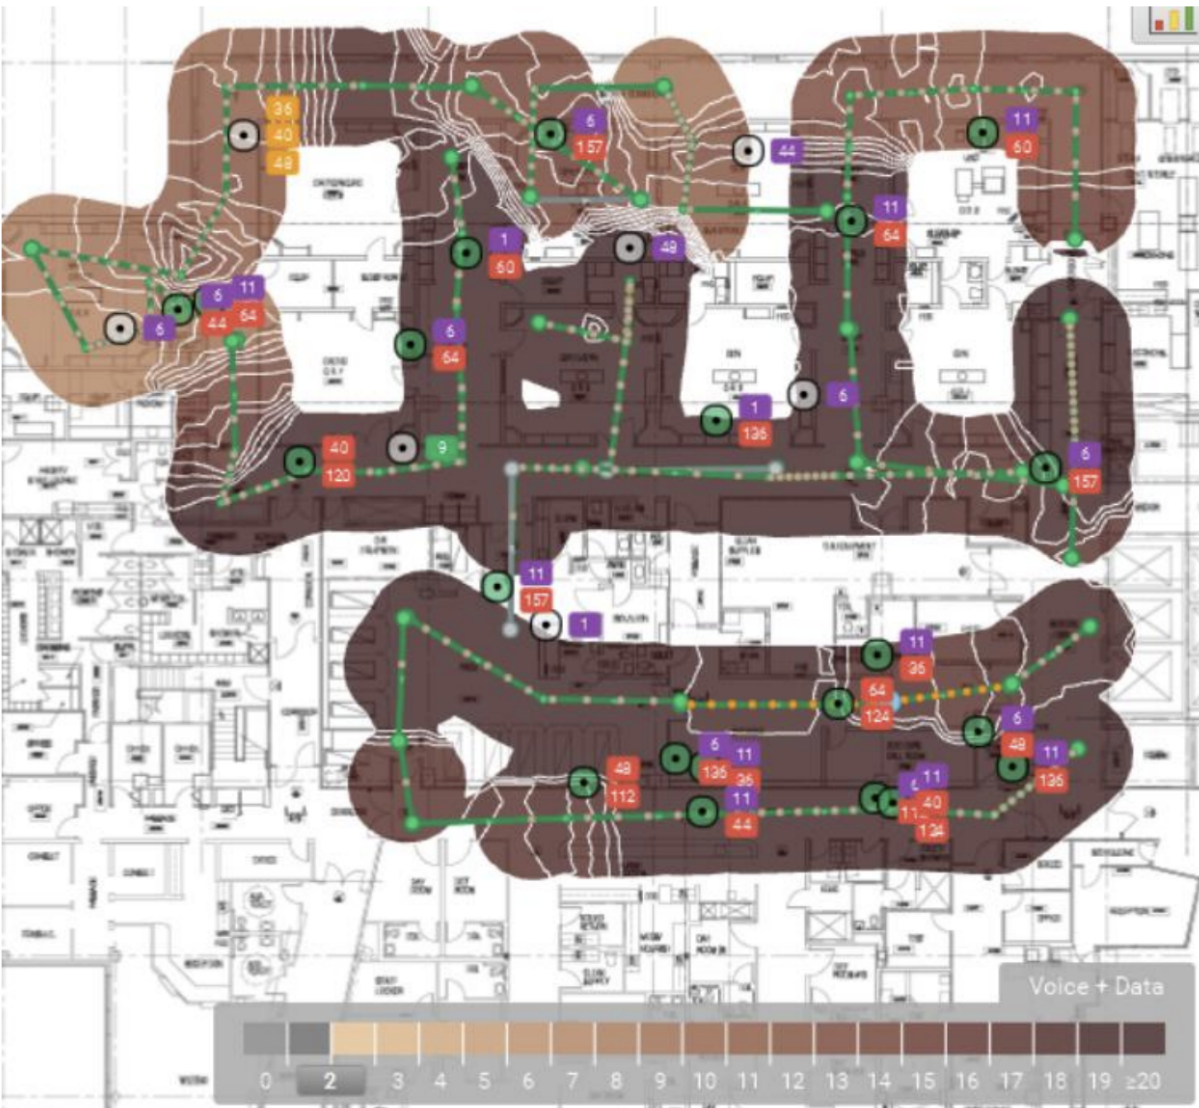
6.4 AP Density

What we see in the channel analysis is also indicative of too much coverage. Looking at the APs heard at each location (next image), we find an overabundance of coverage. This is actually hurting the health of the environment and making roaming more difficult.

In some areas surveyed, we can see over 20 APs sourcing signal that can be detected by user devices.

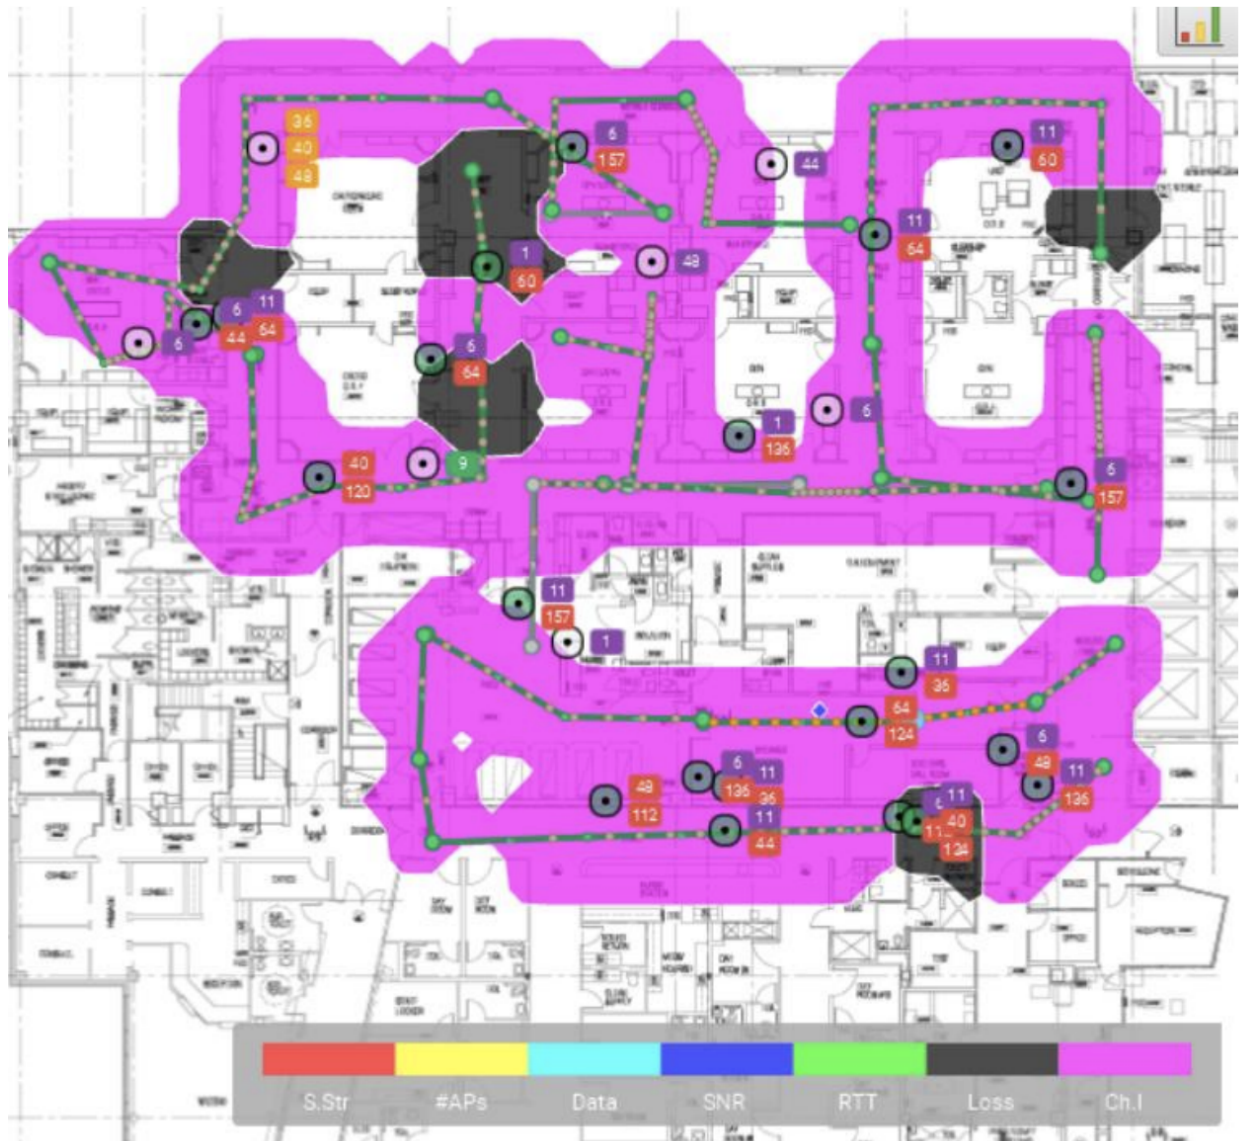
6.5 Issues Summary

What we see here is confirmation that, of all of the other findings, there remains two major issues: Channel interference, and resulting data loss.

There are still some recommendations to further improve the wireless environment. It should be noted that the best recommendation is a redesign of the environment to bring this to a properly functioning medical grade wireless network. In the meantime, these recommendations will help.
