3 Introduction

3.1 Project Background

The scope of this document is to provide an overview of past findings related to a Graphium implementation at a Cisco-based hospital, and outline the changes necessary to remediate them.

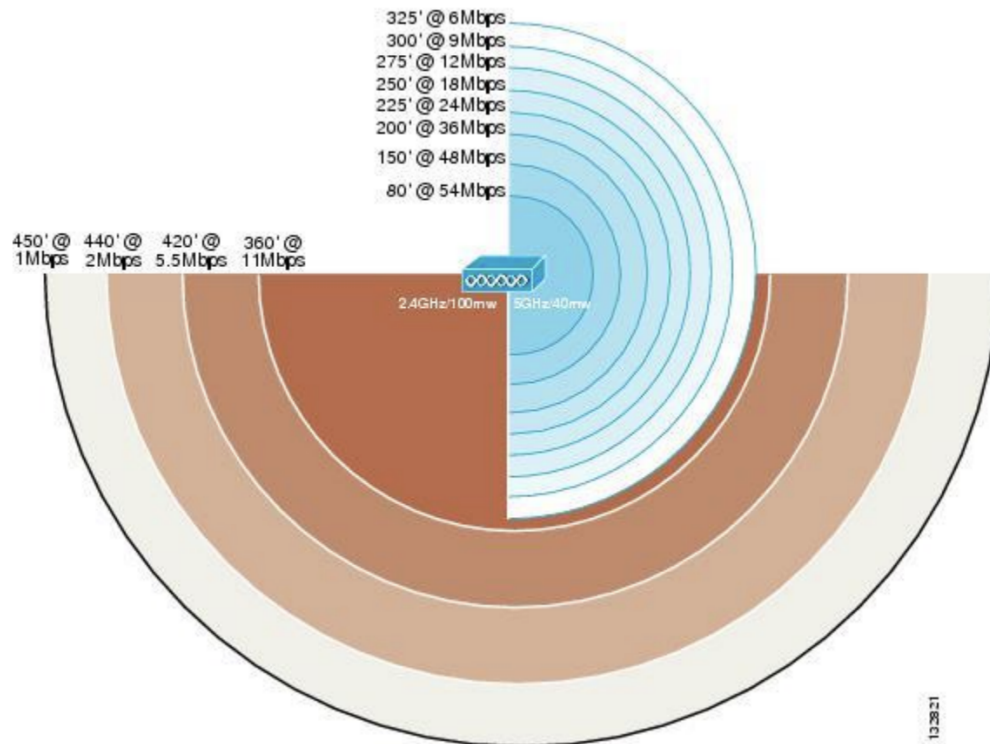
Lower data rates were found to be in use throughout the WLAN. This is not best practice, nor is it ever desired.

The current configuration is allowing the use of the lower data rates. These lower data rates allow for a bit more coverage, but they also hurt the capacity and efficiency of the wireless network. Because of the different modulation techniques used by each different data rate, the lower data rates require more bandwidth for management. This “clogs” the wireless environment by taking up bandwidth. If these lower data rates are disabled (such as 6 Mbps, 9 Mbps, & 12 Mbps in the 5 GHz band at minimum), it frees up bandwidth. Further, this results in clients roaming faster and more effectively as they will not hang on to an AP until the last minute as they would on the lower data rates. This results in mobility that is much more effective.
